# REFURBISHMENT OF TWO SMALL HYDROPOWER PLANTS

P. Tschernutter, M. Adunka, M. Mulley

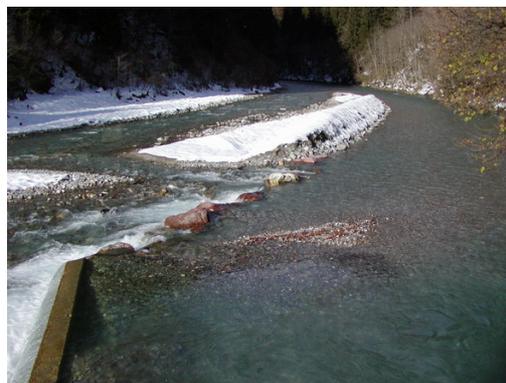
Fig. 2. Upstream longitudinal dam with concrete leading toe wall

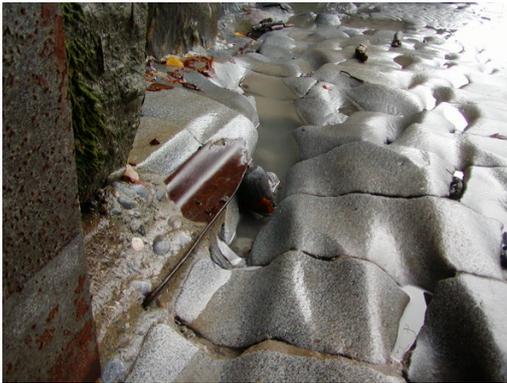
The inspection of stability and impermeability of the existing floating weir and the side wall showed that parts of the structure had larger leakages and that the stability was not assured in some areas of the supporting wall. In addition, it became evident that important operational installations such as the flushing gate sealings, mechanical gate controls as well as timber sluice gates etc. had to be rehabilitated immediately. The lateral stone wall of the floating weir and the floor were sealed and covered with timber boards. Parts of the plant were damaged or completely destroyed and did not fulfil their original functions anymore. Furthermore, the concrete and steel constructions in the intake section and sediment flushing channel showed deep tracks and were damaged due to sediment abrasion.

Fig. 3. Sediment abrasion in concrete and granit lining at the intake

The gravel flushing channel which was damaged the most due to bed load and abrasion was completely renewed and reinforced with a steel lining. In addition, a new gravel screen was added. The two other sediment traps and sand flushing channels were newly concreted; a steel lining was added to the channel edges and the floor was covered with larch boards. A larch boarding was applied on the entire new reinforced concrete floor as well as on the lower reinforced concrete walls. From experience, this type of timber boards is considerably more resistant against fine and coarse sediment loads than conventional concrete. The application of special concrete was not an option due to financial reasons.

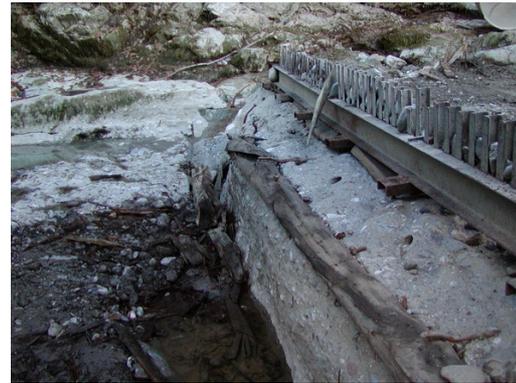
Fig. 4. Damages in gravel flushing channel

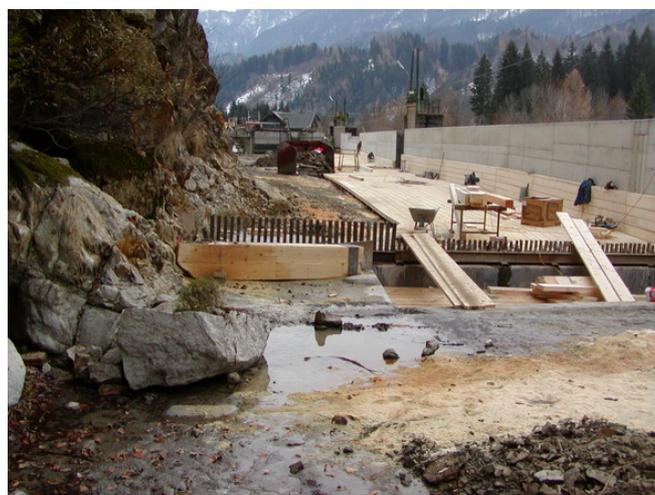
Fig. 5. New weir floor with timber boards and gravel flushing channel

The existing stone wall was rehabilitated by building a new reinforced concrete wall in-front of it. New reinforced concrete was implemented in the floating weir floor which was protected against abrasion with timber boards.

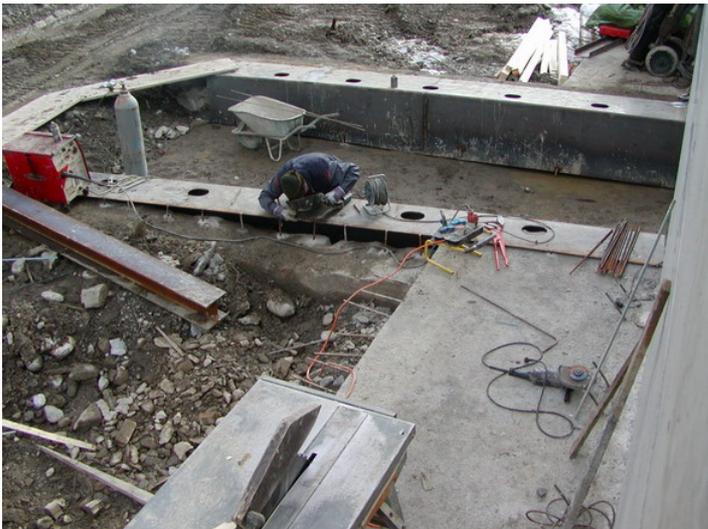
Fig. 6. Steel lining of the flushing channels

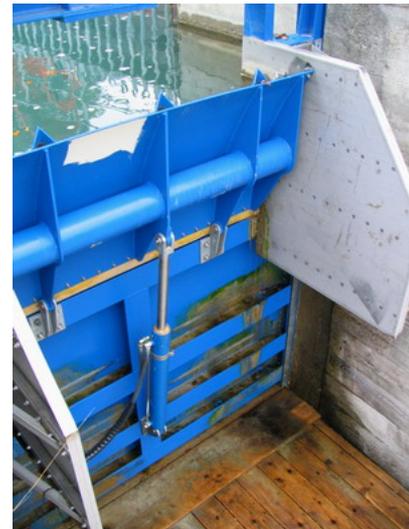
Fig. 7. Sluice gate with flap gate

The existing flushing sluice gates made out of timber and a steel frame were generally in a relatively good condition, however, the sealings were partly heavily damaged and the racks and cogs were strongly used. The bearings were strongly damaged particularly at the gravel flushing gates. Therefore, the owner decided to replace all of the three existing sluice gates with new steel sluice gates with heatable sealings and to use Niro steel for the bearings. In order to remove floating debris more easily, the sluice gate was designed with a flap gate before the HPP water intake. Hydraulic lifting devices with modern control units were installed for all of the three gates.

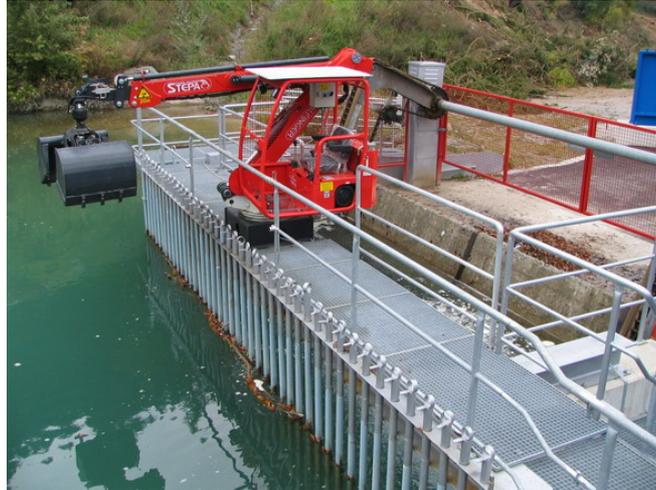
Fig. 8. Coarse screen with pullable rods and grab dredger

The existing fine screen at the HPP water intake was also fully rehabilitated and was equipped with heatable special formed rods. The heating is provided by the biomass heating system of the owner and should prevent the screen rods from icing up. The existing wooden retention bar was replaced by a new coarse screen with screen rods which can be pulled out in winter as well as a catwalk. The existing screen cleaning machine as well as the small grab dredger did not have to be adjusted or changed.

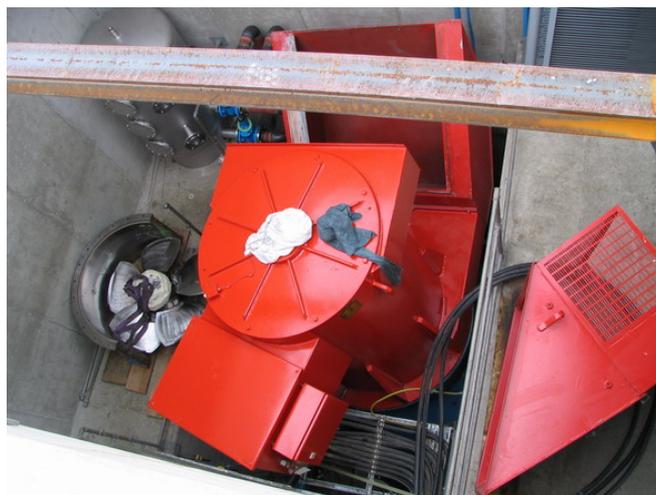
Fig. 9. Installation of the modified generator

To upgrade the generator from the existing limited output of 700 kVA to the required output of 850 kVA, the generator bearing had to be exchanged; an adjustable  $\cos\phi$ -control unit had to be installed; the generator bus bars and generator transmission lines as well as the wiring to the main transformer had to be strengthened and a stronger synchronisation switch had to be installed.

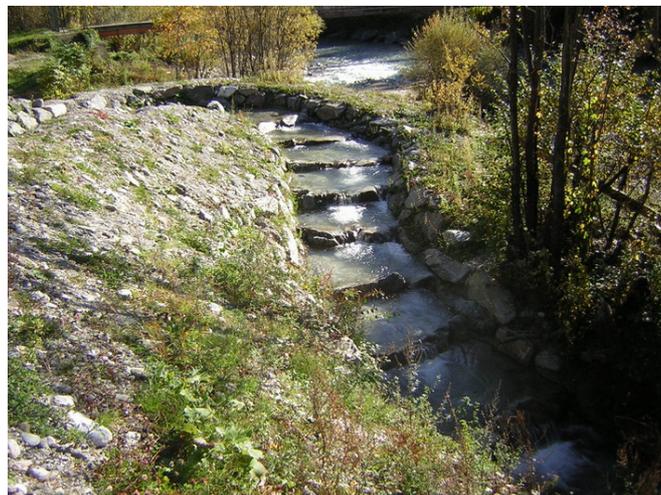
Fig. 10. Fish bypass as basin passage

A basin passage with specially designed and constructed accesses and exits was implemented for the new fish bypass. The consultation of a fish ecologist for design and detailed structuring suggestions was very helpful.

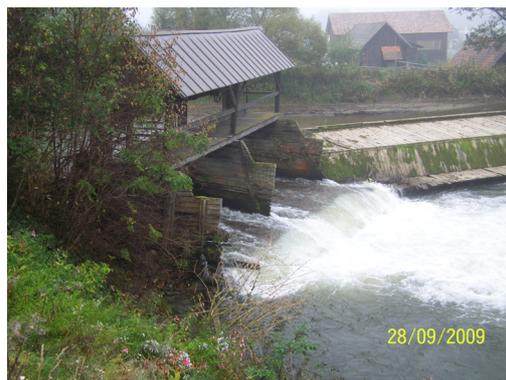
In recent years a deep scour was formed downstream of the old weir which caused an uncontrolled settlement of the weir. Due to the inclination, the lifting devices for the right gate malfunctioned. In 2009 the weir had to be opened and no further HPP operation was possible. The river Gurk was diverted via the open damaged weir.

Fig. 11. Situation of the malfunctioning weir before rehabilitation

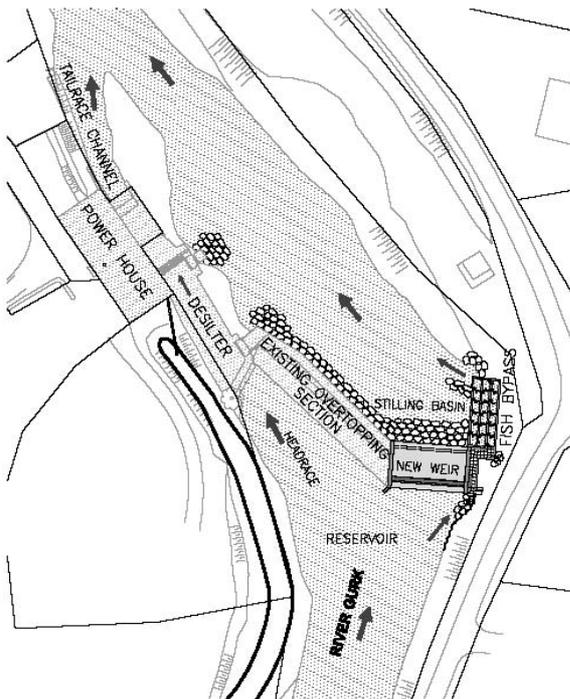
Fig. 12. Layout of the rehabilitated weir

A single-gated weir with a 2.25 m high hydraulic powered flap gate and a width of 12.50 m was suggested. This weir and the existing old overtopping weir can manage the new design flood collectively. It also ensures that the main bridge has a freeboard after a river bed lowering without overtopping at the design flood.

A stilling basin with scouring protection by using a concreted stone revetment was constructed below the weir. The minimum requested weight of the stones was 0.8 t and the medium weight was 1.2 t. In addition, a river bed stabilisation was secured down of the existing overtopping weir by backfilling gravel and constructing a new rock revetment with a width of 2 m. Both of the flushing gates were also secured locally by implementing a new stone revetment.

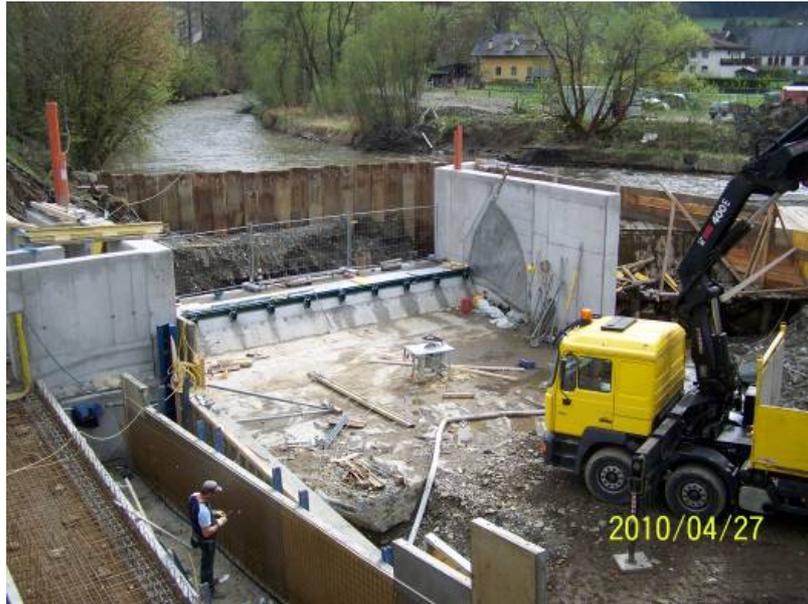
Fig. 14. Weir during construction

To protect the construction of the new weir, a steel sheet wall and a dam were built. The main work was performed at low flow conditions in winter and spring 2010; the water was diverted via two flushing gates. During this phase, river flows of about 40 m<sup>3</sup>/s could be diverted via the existing crib weir and the flushing gates. Down of the weir, a protection dam was constructed with excavation and sedimentation material.

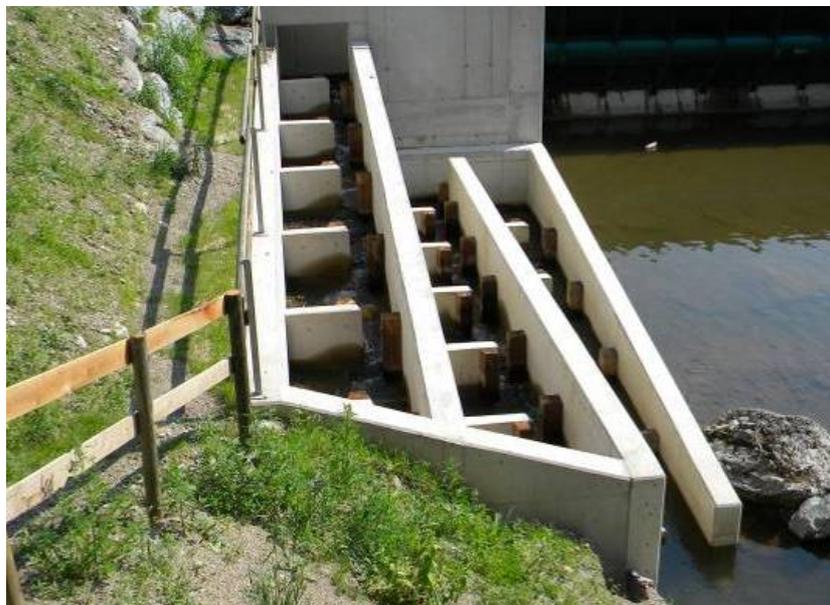
Fig.15. Fish and microorganism mitigation bypass

The previous residual flow dotation via the gate is substituted by a fish and microorganism mitigation bypass at the right river bank. Vertical slots with a difference in water level height of about 15 cm were planned and designed for the autochthonal fish stock.

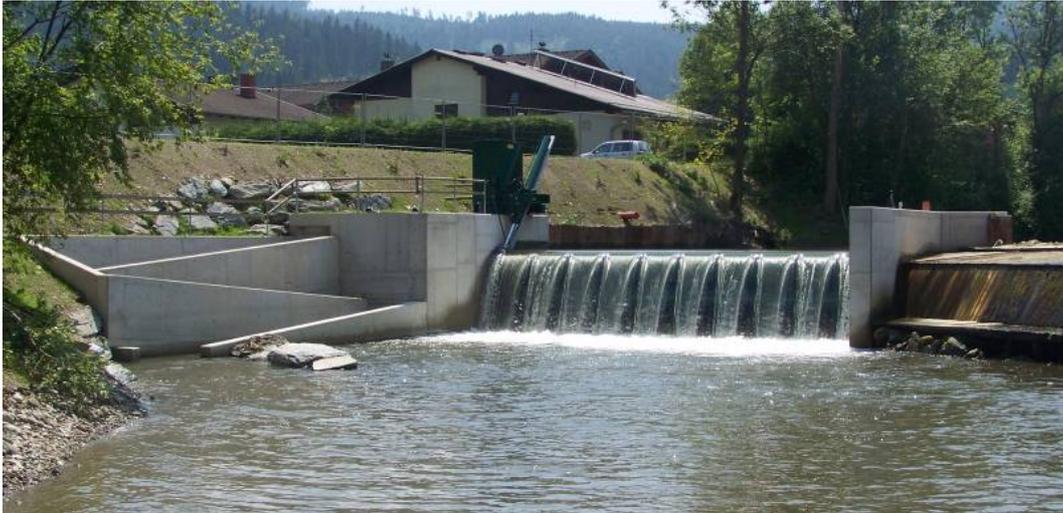
Fig. 16. Weir after rehabilitation
