Silane modified polyether sealant failure in drinking water pipes

V.-M. Archodoulaki¹, G. Kuschnig², <u>S. Lüftl¹</u>, M. Werderitsch²

- 1) Vienna University of Technology, Institute of Materials Science and Technology, Austria
- 2) Vienna Waterworks (MA 31) City of Vienna, Austria

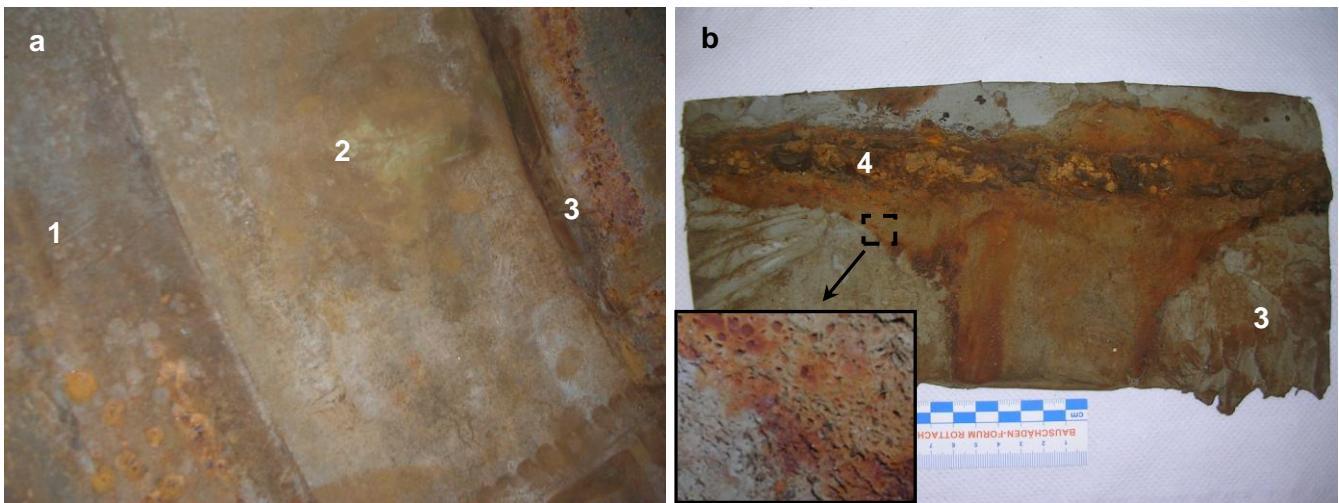
Fig.1. a) sealing system in place after 2 years in service b) back side of a removed sealing system part. 1-cleaned pipe wall 2-cover band with bubble 3-SMP sealant 4-corroded cast iron pipe residues

First the samples were examined with the naked eye: the sealant was discoloured (red, black and white areas) on large areas and corroded residues of the pipe were still adhering (Fig. 1b). In addition in the discoloured area some crevices could be found (insert Fig. 1b). The crevices could have developed during the application or

curing of the sealant. However, in non-discoloured areas such crevices could scarcely be noticed. Further, the samples had a light unpleasant odour that could originate from microbial activities.

The SMP sealant was not fluid enough to penetrate the entire gap of the socket that has been created by the decomposition of the former sealing materials. Thus, soil seepage water entered the through the remaining leaks in the socket joint from the outer side of the pipe. The seepage water caused the corrosion of the unprotected cast iron surface in the socket gap. By this process different (water soluble) iron compounds were generated. These iron based compounds together with some clay minerals [3] and bacteria present in the soil catalyzed locally the degradation of the interface between the cast iron and the SMP sealant.
