## DOCUMENTATION AND DEVELOPMENT OF THE COLUMNS OF THE CHURCH OF ST. CHARLES IN VIENNA

C. Ressler<sup>a</sup>, K. Kraus<sup>a</sup>, W. Höppl<sup>b</sup>

<sup>a</sup> Institute of Photogrammetry and Remote Sensing, TU Vienna, Gusshausstrasse 27-29/E122, 1040 Vienna, Austria  
{car, kk}@ipf.tuwien.ac.at

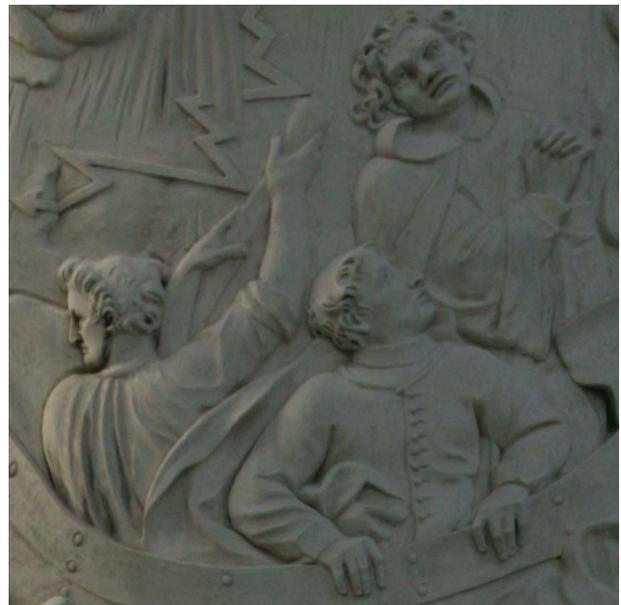
Figure 3: Section (size 1.3×1.3m<sup>2</sup>) of an ortho-photo derived from the Riegl surface model and the Canon photos.

- A surface model with 2cm resolution covering 3×13 m<sup>2</sup>, derived from the Riegl data; see figure 2 (left).
- This surface model overlaid with texture from the Canon photos resulting in a 3D-photomodel; see figure 2 (right).
- An ortho-photo with 3×3mm<sup>2</sup> object resolution derived from the Riegl surface model and the Canon photos; see figure 3.
- A surface model with 1mm resolution, covering about 30×25 cm<sup>2</sup>, derived from the Minolta data; see figure 4.
