MONUMENT FUTURE

Decay and Conservation of Stone

"Monument Future: Decay and Conservation of Stone" – Proceedings of the 14th International Congress on the Deterioration and Conservation of Stone, University of Goettingen and University of Kassel

LIVE AND LET DIE? BIOFILMS ON STONE: POSSIBILITIES, LIMITS AND RISKS OF COMBATING

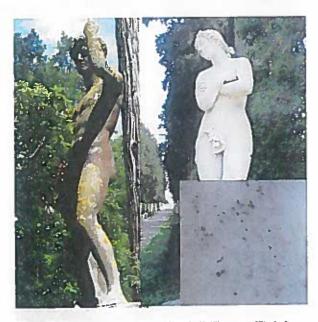
Figure 2: Carrara marble in Parco di Boboli (Florence, IT). Left uncleaned sculpture with dense lichen growth, right cleaned figure: in the close-up it is clearly visible that lichens are already growing out of the rock structure and form new colonies.

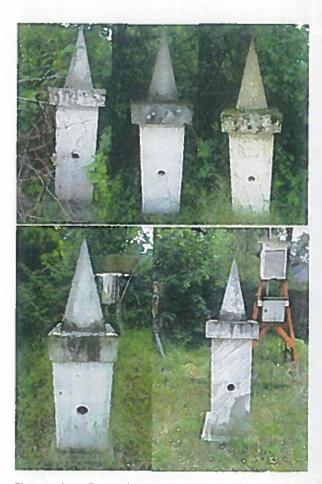
Figure 4: Stone figures after 13 years of exposition.

After 13 years of exposure in the open-air site of the Kartause Mauerbach, all rock types showed a significant colonization with biofilms (Fig. 4). colonization was particularly pronounced on the horizontal and sloping surfaces. There, the water availability is higher than on the vertical surfaces, where the water quickly runs off, and thus the growth of organisms – including mosses – is favored. Strongest visible colonization was observed on those rock types with high porosity: Aflenzer and St. Margarethener sandstone.
