Article

# Risk Assessment of Rock Falls Released from the Former Quarry Near Spitz (Austria)

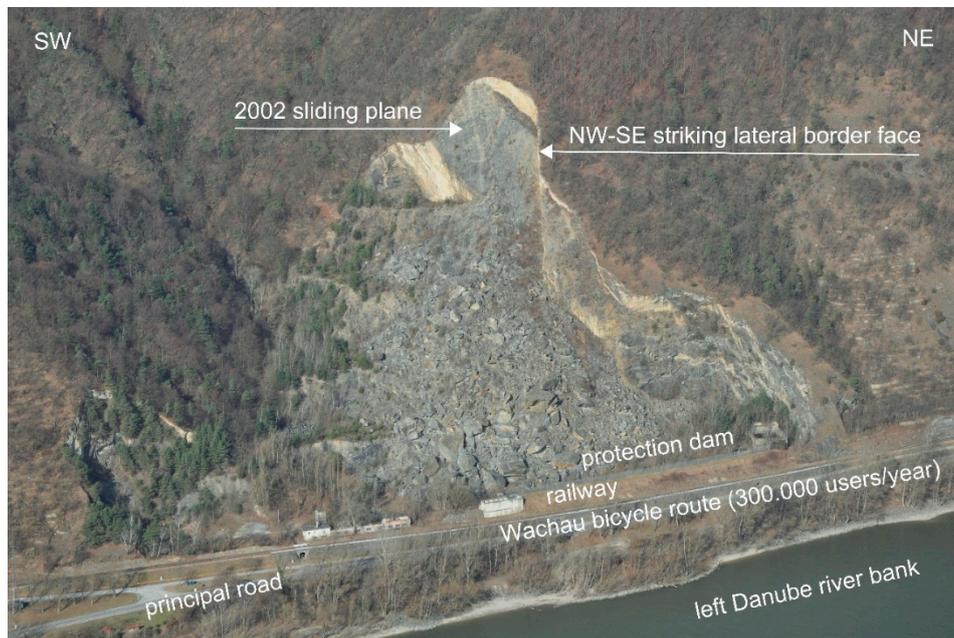
**Figure 1.** The current state of the former quarry of Spitz.

The former quarry of Spitz is situated approximately 1.5 km south-southwest of the township of Spitz an der Donau on the left Danube riverbank. The quarry often changed hands, and many rockslides occurred (Figure 1). The present situation poses a hazard of undetermined intensity to a railway, the Wachau bicycle route (300,000 users/year), a principal road as well as the left Danube riverbank. Several proposals for reducing the risk caused by the present situation have been made. However, the costs for the realization of these proposals (e.g., enclosure and coverage of the traffic routes) would be considerable [1,2].

The rockslide shaping the present state occurred on 11 October 2002 (Figure 1). The rock mass most probably slid down on the same foliation plane, on which the 1984 slide occurred (Figure 4), with relatively low velocity. Thus, the main part of the sliding mass did not reach the railway.

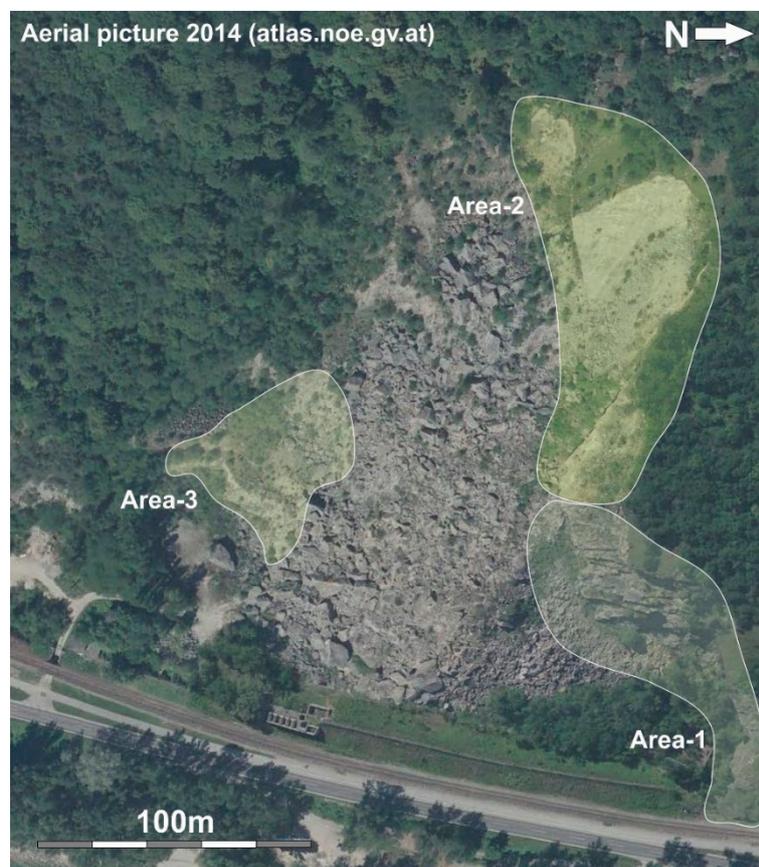
**Figure 2.** Areas of homogenous geological structure (aerial photo from 2014; from: [11]).

The dominating lithology in the quarry consists of coarse-grained massif marbles with calcisilicate layers, which have been deformed under high-grade metamorphic conditions. The metamorphic layering dips consistently towards the southeast. Cm- to m-thick amphibolite layers, oriented parallel to the metamorphic layering, contains more than 50% biotite. The foliation cleavage has very high persistence and has served as sliding planes for all rockslides.

Structural measurements were complemented by a drone surveying flight and the application of Shape MetriX3D [10] in inaccessible places. Shape MetriX3D computes dip, dip direction, position, and distance of discontinuities using digital photos captured from different angles. Based on these data, three different areas could be distinguished within the quarry (Figure 2): Area-1 is mainly characterized by drag folds parallel to the strike of the slope, comprising both the foliation as well as the amphibolite layers. In Area-2, the foliation and amphibolite layers are planar. It contains the major sliding surface and the northwest–southeast striking lateral border face and dips steeply towards the northeast. Area-3 neither contains folds nor shear bands and records only uniformly southeast dipping layering.

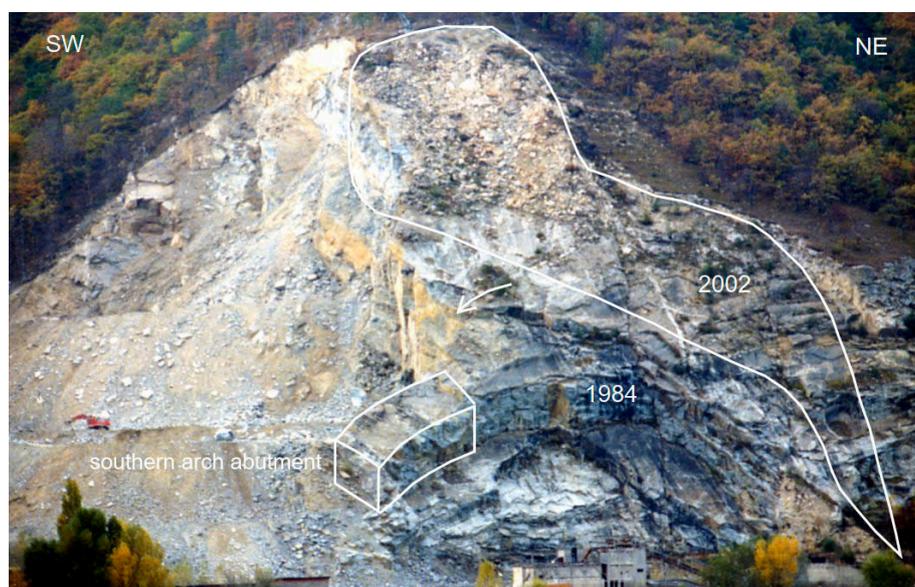
**Figure 3.** Detachments of rockslides on 4 October 1984 and on 11 October 2002.

In order to avoid further foliation undercutting, the direction of excavation was changed. Now the excavation started in the valley south of the quarry in a northerly direction (Figure 3). As a result, the southern abutment of the arch formed by the former excavation was loosened and weakened and consequently failed on 4 October 1984. The rock mass lying above partly slid down but did not reach the railway.
