## Influences on the drying behavior of a concrete ceiling below a cold attic

To cite this article: Thomas Lewis *et al* 2021 *J. Phys.: Conf. Ser.* **2069** 012034

**Thomas Lewis, Andreas Sarkany, Ernst Heiduk, Manfred Grüner, Thomas Bednar, Harald Hofbauer**

TU Wien, Institute of Material Technology, Building Physics, and Building Ecology, Research Unit of Building Physics, Austria

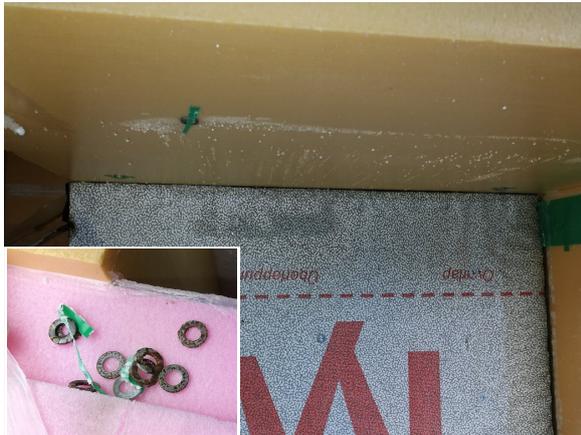
**Fig. 4.1:** Condensate at the outer insulation with an sd-value of the vapour retarder on the slab of  $\approx 0.2$  m. Low left: Rusty washers used as distance keepers between the EPS panels.

- (i) *case A*, low *sd-value* of the vapour retarder
  - (a) During the experiment some sensors gave up their function due to condensate. Destruction started with the sensors closest to the slab.
  - (b) Initially at the top edge of the concrete slab a higher temperature was observed (29 °C) than the setpoint of the heating mat (26 °C). The authors attribute this to the hydration heat of the concrete.
  - (c) Massive condensate was observed when opening the sample ( Fig. 4.1).
- (i) *case B*, high *sd-value* of the vapour retarder
  - (a) No more sensors lost their function.
  - (b) There was still – though much less – condensate observed at the outer insulation panels, at the one adjacent to the purlin and as well at the other opposite it ( Fig. 4.2).

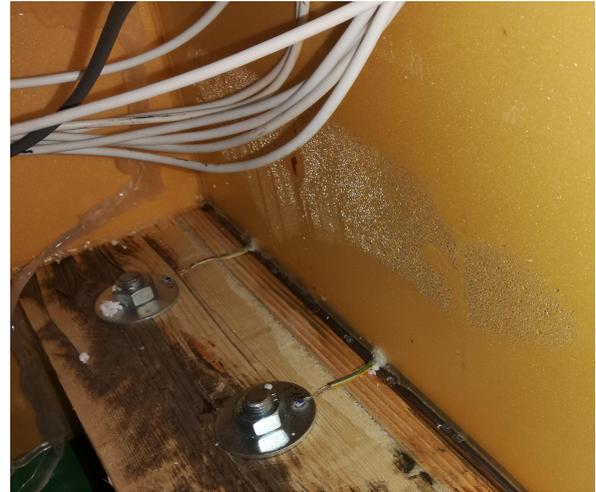
**Fig. 4.2:** Condensate at the outer insulation even with a vapour barrier of  $> 100$  m separating the concrete slab from the attic.
