# REFURBISHMENT OF TWO SMALL HYDROPOWER PLANTS

P. Tschernutter, M. Adunka, M. Mulley

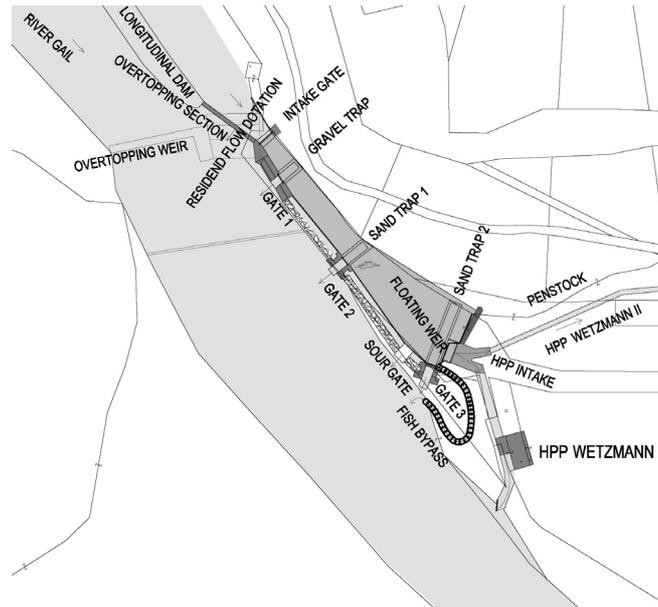
Fig. 1. Position of floating weir and river diversion

The river diversion to the weir was situated at the outer curvature and therefore ideal for wood floating. Since the river Gail is extensively carrying sediments, a large amount of coarse sediments was deposited each year which was stored above the weir and only transported into the successive flow section of the river Gail via the weir during larger floods. These edge conditions were partly not satisfactory for operating a hydro power plant. Thus, a channel had to be excavated at the outer curvature of the river at least once a year. In order to improve the hydro power operation, a longitudinal dam was additionally banked up from river sediments in the river bed of the Gail. Even though the longitudinal dam was annually overtopped and partly displaced again during medium water flow, the situation was improved during normal water flow. In addition, a concrete leading toe wall was implemented immediately before the intake. Supplying the intake with the river flow is difficult without a deep channel (talweg), a longitudinal dam based on river sediments and a concrete leading toe wall and not guaranteed due to the constantly changing river bed conditions. Due to operational reasons and despite the improvement measures in the inflow area, it was and still is necessary to close the intake during medium and larger floods to prevent an increased amount of coarse sediments and driftwood etc. from entering the floating weir.
