SETTLEMENTS AND HOUSING ON NIAS ISLAND ADAPTATION AND DEVELOPMENT

KEY WORDS: Nias, earthquake resistant architecture, adaptive structures, vernacular architecture, settlement structure

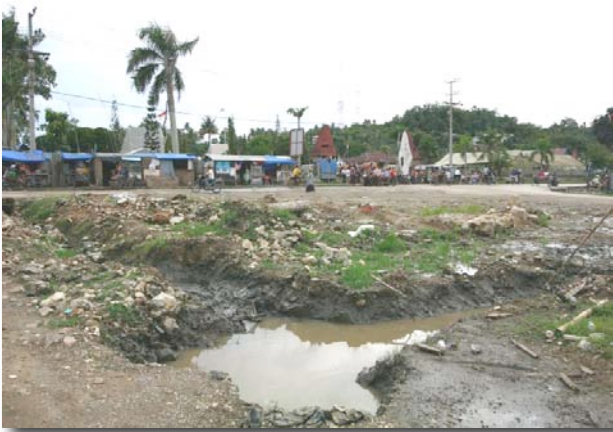
Centre of Capital Gunung Sitoli, August 2005

The biggest damage through the earthquake happened in the populated coastal areas especially in Gunung Sitoli, enhanced by the bad alluvial soils and the cheap concrete structures. These were responsible for 758 casualties, 705 persons badly hurt and 781 people hurt. 84,388 persons are still internally displaced (IDP), living in camps or with host families.

Reports from local authorities stated that 70% of buildings collapsed in Gunung Sitoli town. Telecommunication facilities were totally destroyed. 50% of all bridges were destroyed and land transportation blocked. Also electricity was cut partially.

Significant differences could be observed considering building materials. Most casualties were victims of collapsing concrete structures. The benevolence of wood, not only in the traditional, but also in the Malayan style buildings saved lives.

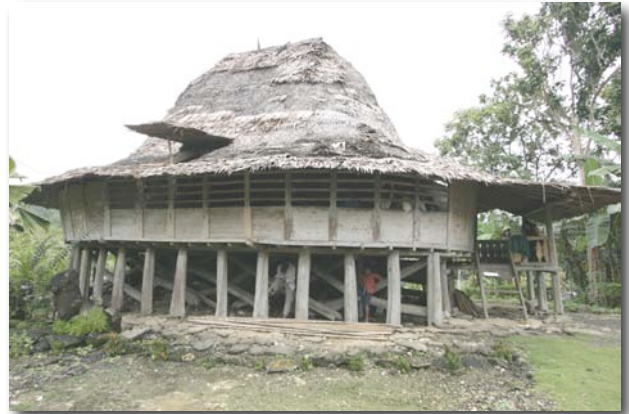
North Nias house, Sihare'ō Siwahili

North Nias houses have an oval floor plan, rows of diagonal bracings (X form) in the substructure and a huge hat like roof. Central pillars lead from basement to ridge pole. The façade is all around the house.

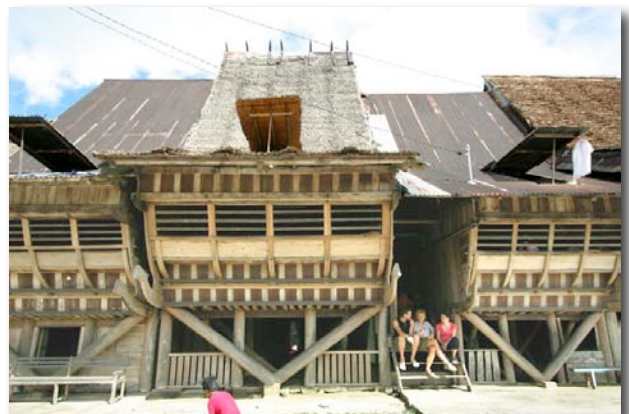
South Nias houses, Bawomatalou

Houses of South Nias have a rectangular floor plan, straight load bearing sidewalls and a slanting front façade. Significant is the v-shaped diagonal bracing in the front façade and the very high steeply pitched roof. Houses are built side by side in a row. So the house has just one front façade with open louvers and decoration.

The houses rest on a structure of vertical and oblique posts which are placed on slabs of stones. Vertical posts and X and V bracings are the elements of this substructure. The three-dimensional structure offers great resistance and has the required elasticity because it does not settle in the ground. The

separation of the house from the ground is the most important concept for earthquake resistant building in traditional form.

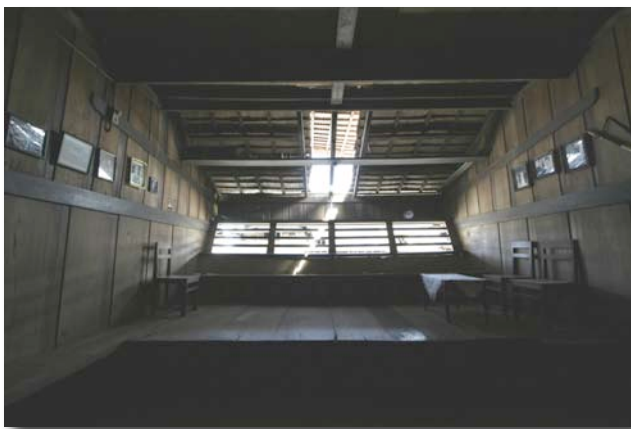
Interior of the front room of a South Nias house

Large openings over whole front facades provide good ventilation. They enable the inhabitants to overview the neighbourhood. Depending on the distance to the opening a good control of contact and visibility is possible.

Houses are hardly furnished, the inhabitants belongings stored in chests. The most important piece of furniture is a long plank below the louvers, which the tenants use as a bench.

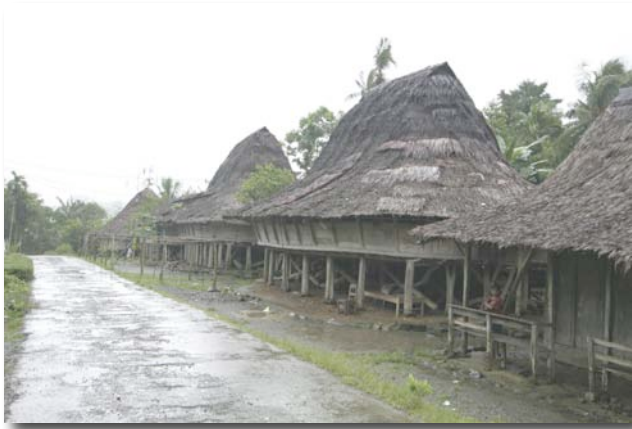
North Nias settlement, Onolimbu

Traditional villages in the northern part of Nias consist either of groups of 6 to 12 oval houses, which are being oriented longitudinal-side towards the street, or single cottages far away from each other, also in oval shape.

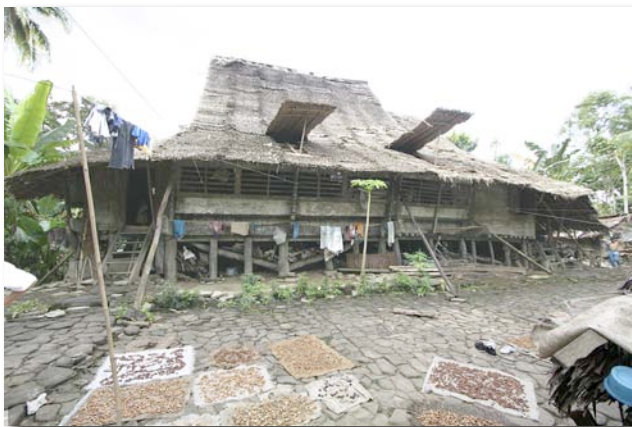
Middle Nias house, Gomo area

In Middle Nias houses have a rectangular floor plan, slanting sidewalls and an oblique front façade, which is often decorated with carvings and/or colour. In the substructure v-shaped diagonal bracings are significant. Layouts of Central Nias houses can vary from rectangular to cross-shaped. The hybrid typology of these houses has not yet been fully examined. Research on its origin and influences on North- and South Nias types will form an important part of our project.

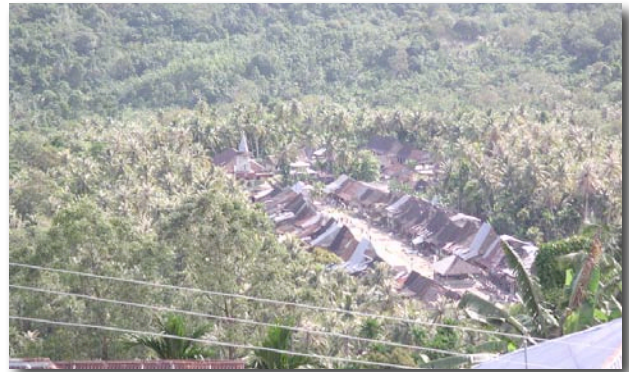
Village of Orahili, South Nias

South Nias is famous for the traditional rowhouse - settlements. Villages in South Nias are situated on hills and are named after their location. In the past, when warfare and headhunting raids were endemic, an outer palisade of sharpened bamboo stakes fortified the village with a deep ditch behind. The settlements can consist of several hundred dwellings arranged on either side of paved street, which may be up to 100 meters long. The basic linear street pattern can be enlarged to T- or L shaped configuration.

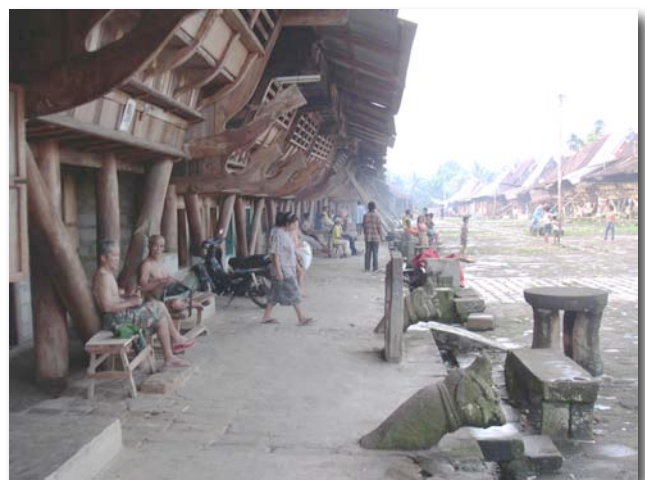
Hiliamaeta, South Nias

The settlements can consist of several hundred dwellings arranged on either side of paved street, which may be up to 100 meters long. The basic linear street pattern can be enlarged to T- or L shaped configuration. The form of these villages reflects

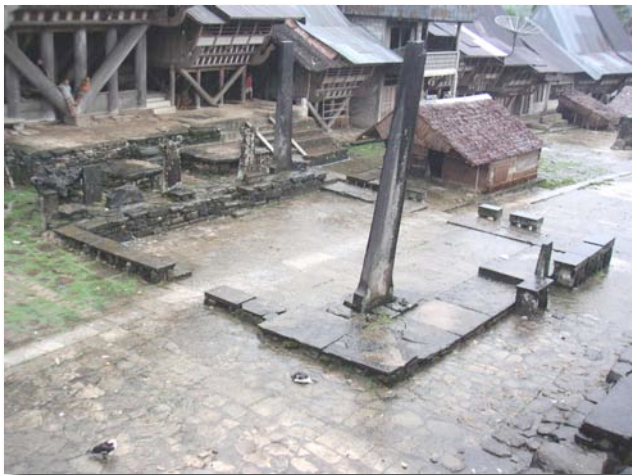
Centre of Hilinawalö Fau, South Nias

Meeting places are still very important in the villages and are frequently used for village gatherings. The traditional building type of the meetinghouses (*Osal*) has not survived (Schröder 1917), but modern meetinghouses are common and situated in the centre of the village. The traditional stone benches in front of the Omo Sebua are still used for village meetings.

All parts of the settlement spaces form a hierarchy that refers to the transition from private to public. The most private part is on the backside of the house. The living room is in front. Between two coupled houses covered entrance terraces are shared by pairs of adjacent households. Neighbouring houses are also connected with doors to provide escape routes, which were needed in the past. In the covered area in front of the houses

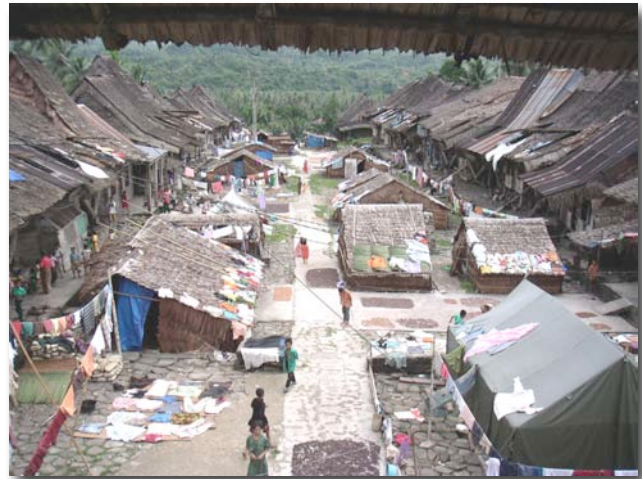
Hilinawalö Mazinö, South Nias

The space between the *öli batu* and the public walkway in the middle belongs to the respective house and has to be maintained by the owner. It can be used for drying agricultural products or laundry. In the case of the catastrophe, which caused heavy damage to the houses, the space is used for temporary shelters. The only real public space is the narrow walkway.

Because of the remoteness of the villages in the south help has not yet reached most places. The lack of building material prolongates the situation. People don't have the resources for the maintenance of the houses any longer. Bad maintenance is the main reason for damage of traditional houses.
